QUESTION :

My patients complain about food impaction around single implant restorations. Can this be managed and how can I prevent it?

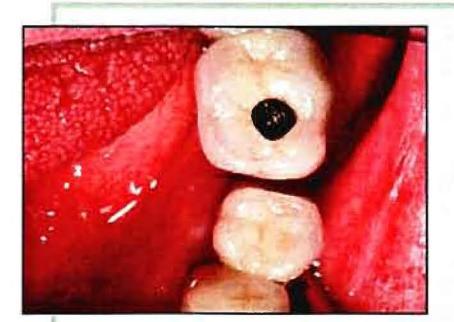
Figure 1: An interproximal contact has opened between the second premolar and first molar due to mesial movement of the second premolar.

here are many reasons for food impaction, but it may occur more often around implants because they are different from natural teeth in many respects. When a natural tooth is extracted, there is often a loss of interproximal papilla, which may not be recreated with an implant restoration. A larger issue is the fact that healthy implants exhibit no mobility, whereas natural teeth move varying degrees based on their periodontal condition and the forces placed on them. This movement is not very noticeable until an implant becomes a point of reference and movement of natural teeth becomes obvious (in relation to the stationary implant). The difference in movement makes both placement of a restoration with an adequate interproximal contact and maintenance of the contact difficult. During the recall period, when we examine occlusion as well as interproximal contacts, neighbouring teeth have often moved causing an opening of the contact (Figs. 1, 2a and 2b).

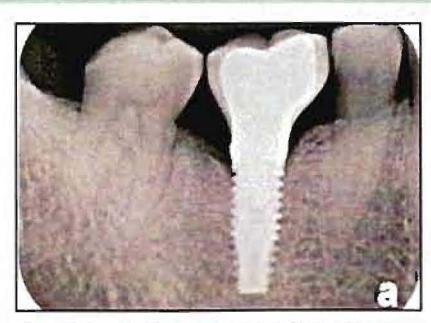
Figure 2a: Radiograph of implant crown at the time of crown placement showing acceptable mesial contact.

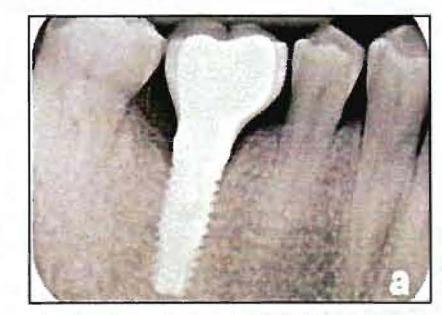
Figure 2b: Radiograph of implant crown at 6-month recall appointment showing an opening mesial contact.

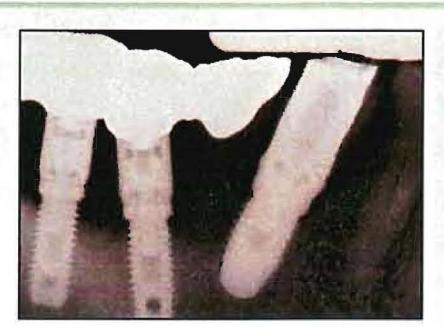
Figure 3: An open mesial contact between an implant (45) and tooth 44 has allowed caries to develop on the distal surface of tooth 44

An open contact is associated with impaction of food debris in soft tissue and caries in the neighbouring teeth caused by inadequate cleaning of the interproximal debris. As the contact opens further, restoration of neighbouring teeth may be required due to caries (Fig. 3). If left unchecked, caries can lead to a need for endodontic treatment and even extraction.

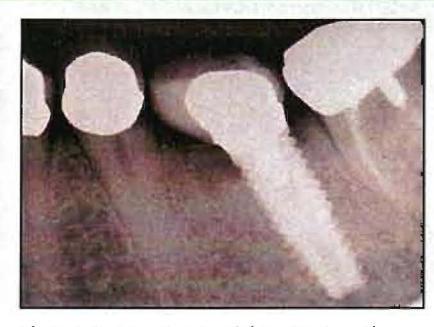
Figure 4: An open mesial contact on the implant in the 36 position has allowed collection of debris and development of caries at the gingival crown margin of tooth 35. The crown on tooth 35 was replaced.

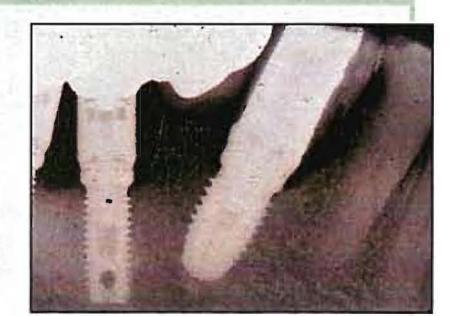
Figure 5: An open contact has been restored by cutting into the restorative material along the mesial edge and bonding additional material to it. The carious lesion in the distal surface of tooth 44 must now be restored.

If the patient does not want the neighbouring tooth adjusted, the contact can be closed by slot preparation of the implant crown surface, etching with hydrofluoric acid, silanating the ceramic surface, then bonding composite resin to the area (Fig. 5).

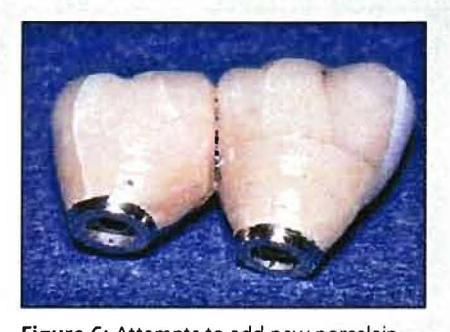
Figure 6: Attempts to add new porcelain to a prosthesis that has been in the mouth for an extended period often causes catastrophic failure of existing porcelain. Fractured porcelain must be stripped from the metal substructure and replaced.

screw-retained crown or a cemented crown using temporary cement or built-in design mechanisms allowing easy removal. The crown can then be removed from the mouth and the porcelain removed from its substructure and reapplied to a greater interproximal dimension. Note: new porcelain cannot be added to old porcelain that has been in the mouth for an extended period; therefore, porcelain must be replaced. Forward planning is useful, as one can design the final restoration from material that is easily bonded to so that future additions and repairs are better supported (Figs. 6 and 7). Implant dentistry is an excellent way to replace missing teeth. However, because natural teeth and implants move differently, one must be vigilant during the maintenance phase of implant dentistry. *

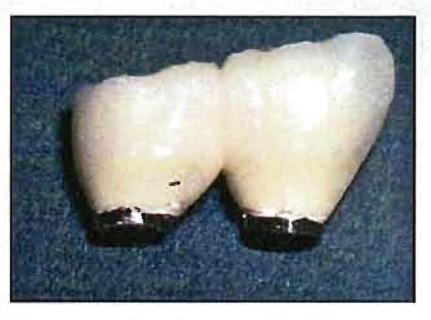
Figure 7: Rather than porcelain, laboratory-cured composite resin can be applied to metal and serve as a final restoration. In future, new material can be easily added intraorally.
