PORCELAIN FRACTURE REPAIRS USING NEW CHEMICALLY ACTIVE BONDING RESINS

A discussion of 4-META containing resin and two case reports illustrating its use in the repair of porcelain fractures

BY ZCHAK BARZILAY, DDS

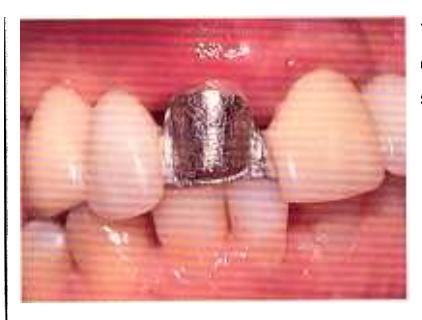
A 35-year-old male presented with a fractured porcelain facing on tooth 11 (Fig 1). The fracture exposed the entire metal substructure and exposed tooth structure at the margin as a porcelain butt margin was involved. Because of time and financial restrictions, replacement of the restoration was not possible and a repair of the fracture was attempted.

1. Fractured porcelain facing exposing metal and tooth structure

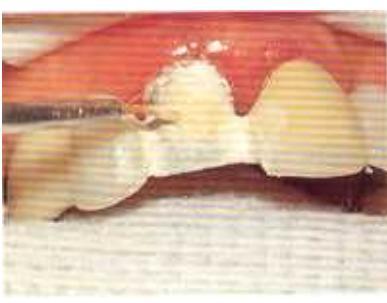
2. Composite resin opaque applied to the 4-META surface. Note that the 4-META completely covers the metal surface as well as the exposed tooth structure

Super Bond C&B monomer was mixed with a ratio of 4:1::monomer:catalyst, and brushed onto the metal surface. Using the activated liquid, 4-META opaque powder was picked up on a brush and applied to the metal surface as well as to the exposed tooth margin. This was allowed to set for a period of eight minutes until the 4-META set and was hard. Composite resin opaque liquid (Durafill Color VS, Kulzer Inc., Irvine, California) was then applied onto the 4-META surface (Fig.2). and cured for a period of 40 seconds. This was then followed by an incremental application of a veneering composite resin (Durafill VS. Kulzer Inc., Irvine, California)

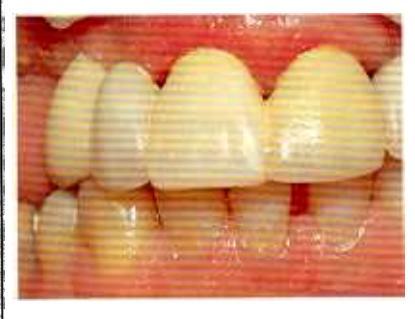
until the facing was built and cured. Polishing and occlusal adjustment followed in the conventional manner (Fig 3).

This repair has now been in place for 12 months and appears to be doing well.

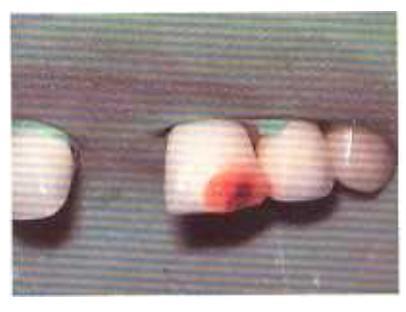
A 40-year-old female patient presented with a fractured porcelain-fused-to-metal restoration. The fracture included the distoincisal corner of tooth 21 and exposed porcelain as well as the metal substructure. Several attempts had been made to repair this fracture using a silane coupler to attach composite resin to the exposed porcelain but success was short-lived, lasting no more than one month.

4. The exposed porcelain and metal at the fracture site is covered with hydrofluoric acid in order to etch the porcelain

The crown was isolated using a rubber dam, and 9.5 percent hydrofluoric acid was placed on the exposed metal and porcelain. This was left in place for five minutes and then rinsed for one minute (Fig 4). A silane coupler was applied to the etched

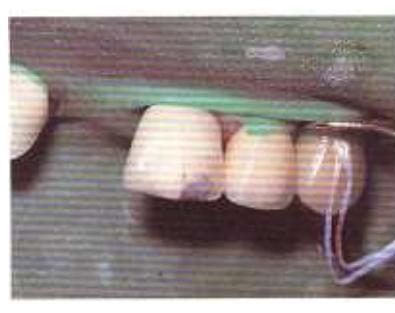
5. 4-META applied to the meta of the fracture site (ivory powder)

porcelain surface (Scotchprime, 3M Dental Products, St. Paul, Minnesota). Super Bond C&B was then mixed and applied as previously described using the ivory powder, because it was felt that the opaque powder would be too opaque (Fig 5). Composite resin opaque liquid was then followed by a composite resin veneer application (Fig 6).

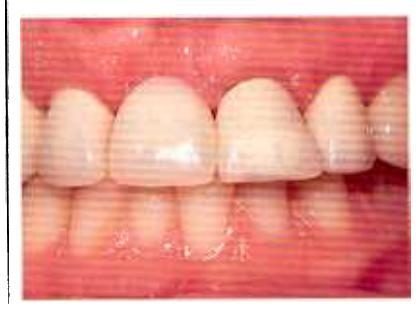
6. Completed porcelain repair

This restoration has been in place for eight months.
