Splinting Teeth — A Review of Methodology and Clinical Case Reports

• Izchak Barzilay, DDS, Cert. Prostho., MS •

Splinting teeth to each other allows weakened teeth to be supported by neighbouring teeth, although the procedure can make oral hygiene procedures difficult. Several methods for splinting teeth, both extracoronal and intracoronal, as well as the materials commonly used for splinting, are described and illustrated. Two case reports are used to demonstrate the situations in which splinting might be appropriate.

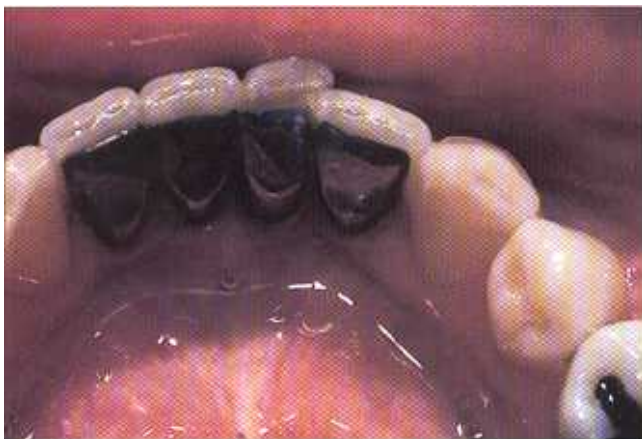
Figure 1: Metal splint created from non-noble metal has been bonded with Metabond C&B cement and is being used to secure mobile teeth.

Extracoronal resin-bonded retainers, which can be fabricated in the dental laboratory, serve to strengthen the overall bonded situation. The splints are usually cast from metals, usually non-noble alloys that can be electrolytically or chemically etched (Fig. 1). Recent innovations in materials allow these frameworks to be air abraded and then cemented in place with an adhesive resin cement, such as Metabond C&B (Parkell Inc.,

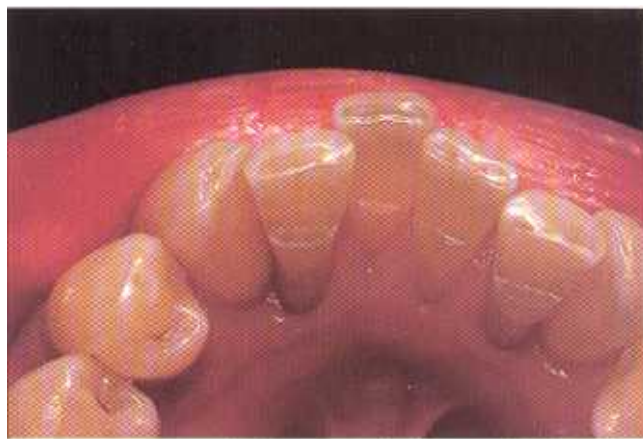
Figure 2: Mobile teeth have been prepared with cingulum rests to help support an extracoronary composite-resin-based splint.

Newly developed laboratory-cured composite resins such as DiamondCrown (Biodent Inc., Mont-Saint-Hilaire, QC) claim improved diametric tensile strength and bonding capabilities. These materials may be considered for use in extracoronal applications (Figs. 2-4). No long-term clinical data are available for these materials; however, they seem promising at this time.

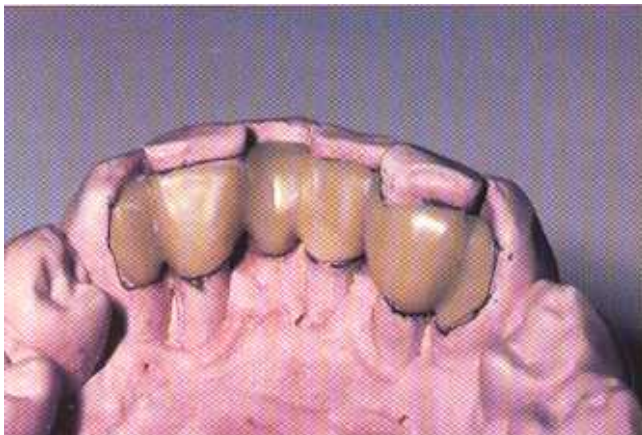
Figure 3: A composite-resin-based splint has been fabricated from DiamondCrown material. Once polished, it will be ready for cementation.

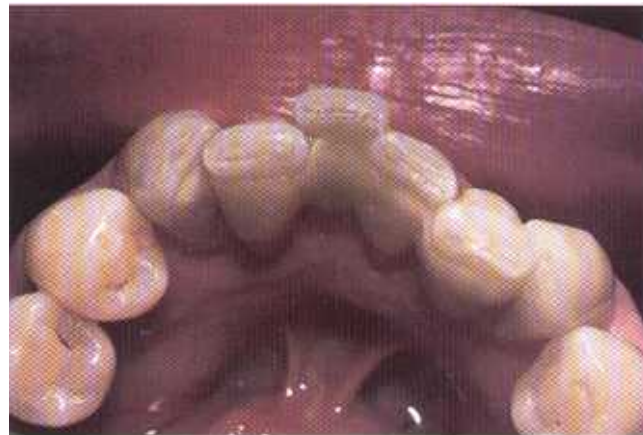
Figure 4: DiamondCrown splint has been cemented (bonded) under rubber dam isolation. This material exhibits superior flexural strength and may be useful in extracoronary splints.

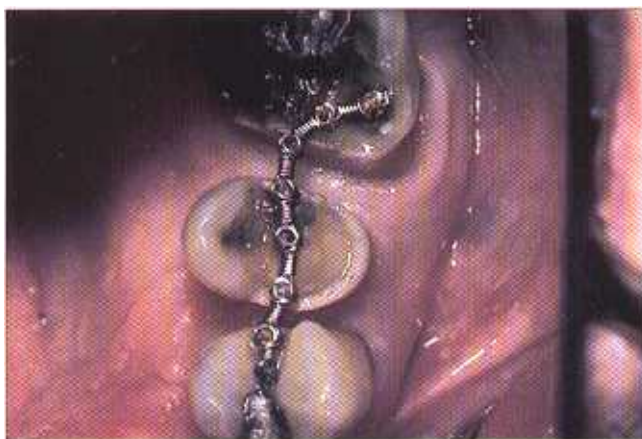
Figure 5: Metal-based wire splint (Splint-Lock System, Whaledent Inc., New York, NY) is secured to mobile teeth with individual metal-based pins. The metal splint is then covered and bonded to the mobile teeth with composite resin.

Intracoronal methods are also available. Composite-resin restorations can be placed in adjoining teeth and cured to eliminate any interproximal separation. These restorations can be further reinforced with metal wires, glass-reinforced fibres or pins (Fig. 5). If restoration of the mouth includes crowns, the crowns can be splinted to each other by solder joints or precision attachments. The use of attachments affords the practitioner the ease of preparing nonparallel abutments yet achieves a splinted result.

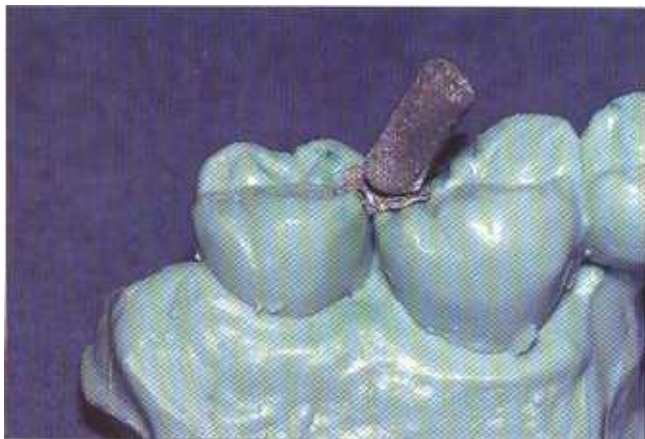
Figure 6: Inlay made from non-noble metal has a handle and has been cast, fit to the master cast and etched; once the inlay is cemented in place, the handle is sectioned and removed.

The crowns on teeth 26 and 27 consisted of porcelain fused to metal, so splinting would involve bonding to metal as well as porcelain. Back-to-back inlays with dovetail designs were prepared (MO in tooth 27 and DO in tooth 26). A polyether impression was made (Impregum, ESPE America Inc., Norristown, PA), and an epoxy die was poured. An inlay based on this die was waxed to extend from tooth 26 to tooth 27, across the interproximal area. The wax pattern was invested and cast in a nickel-chrome-beryllium alloy (Pisces, Ivoclar/Williams USA, Amherst, NY) (Fig. 6). The inlay was air abraded (microetched) with 25- μ m aluminum oxide and thermochemically etched (Assure-etch, Ivoclar/Williams USA, Amherst, NY) in preparation for cementation.

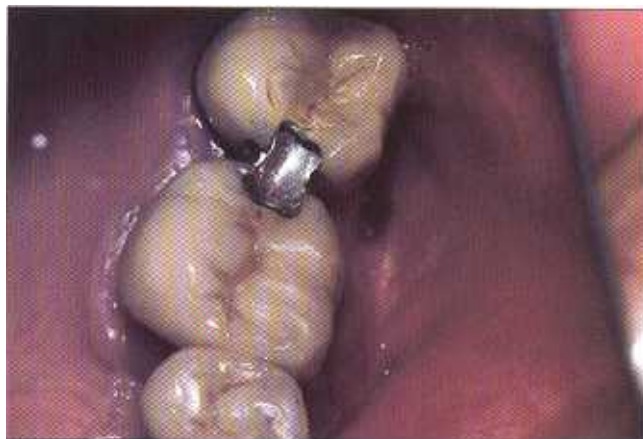
Figure 7: The inlay has been cemented with Metabond C&B. The inlay remained secure after 4 years of service.

the inlay surface was treated with a combination of air abrasion of the exposed metal surface and etching (with 10% hydrofluoric acid for 5 minutes) of the prepared porcelain surface. The etched porcelain surface was then primed with Etch Free (Parkell Inc., Farmingdale, NY), and the inlay was bonded in position with Metabond C&B cement. After a 10-minute set, the inlay was adjusted for occlusion and polished (Figs. 7 and 8).

The patient has been recalled yearly for the past 4 years, and there has been no change in the contact region. The inlay restoration has been secure, and there are no signs of deterioration in the material or the bond to the existing restorations.

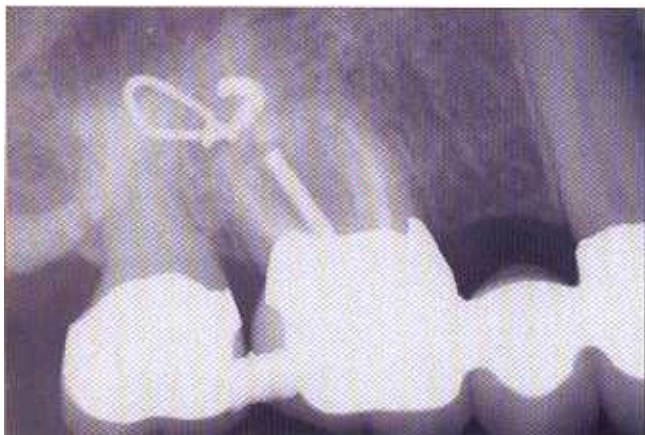
Figure 8: Periapical radiograph shows the splint bonded to the 2 crowns, which are made of porcelain fused to metal. The inlay appears suspended in the porcelain portion of the restoration.

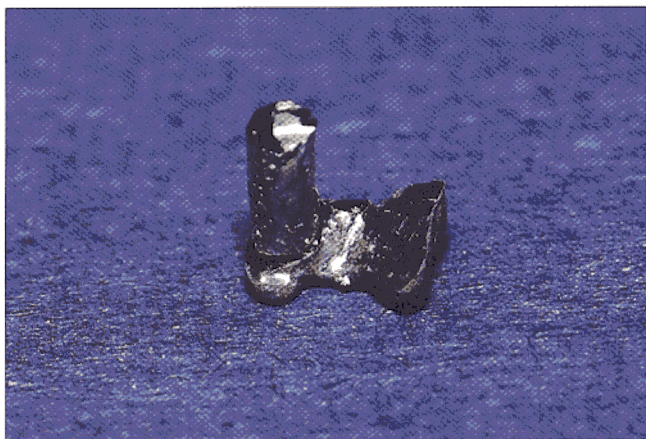
Figure 9: Inlay restoration is fabricated with a handle for easy intraoral manipulation. The handle will be sectioned once the restoration is bonded in position.

A "double-dovetail" restoration was prepared in the disto-occlusal surface of tooth 36 and the mesio-occlusal surface of tooth 37. A polyether impression of the preparation was made, and an epoxy die was fabricated. A wax pattern was made and cast in non-noble alloy. A handle was left in the casting for easy manipulation (Fig. 9). After the fit of the casting had been verified, the casting underwent air abrasion and thermochemical etching. A rubber dam was applied, and the intraoral restorations were treated according to their material composition. The preparation in the gold crown (tooth 37) was air abraded, and the preparation in the porcelain-fused-to-metal crown (tooth 36) was etched with hydrofluoric acid (10%) for 5 minutes and treated with a silane coupling agent (Fig. 10). The restoration was then cemented with Metabond C&B. After complete setting of the cement, the handle was sectioned, the occlusion adjusted and the restoration polished. The contact has effectively been sealed for the past 3 years (Fig. 11).

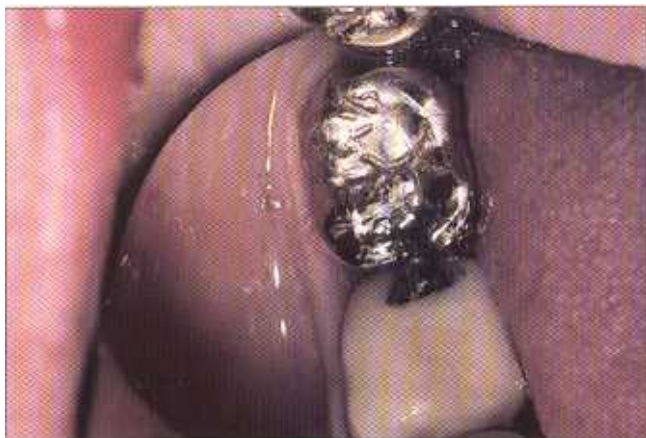
Figure 11: The metal splint has been bonded in position. The splint has been functioning without complications for 3 years.

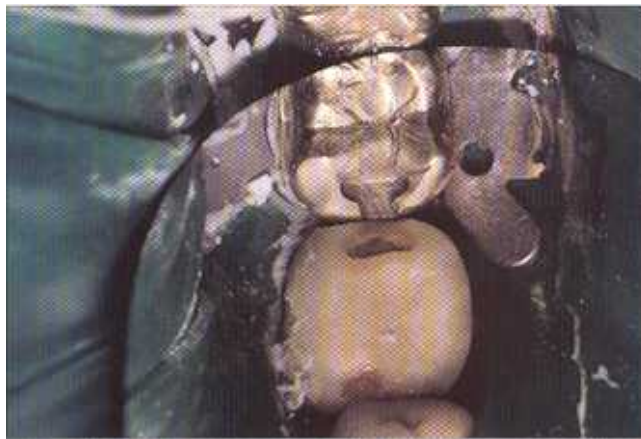
Figure 10: Teeth 36 and 37 have been isolated and treated on the basis of their respective materials. The metal surface (tooth 37) has been air abraded (microetching), and the porcelain surface (tooth 36) has been etched with hydrofluoric acid. The crowns are now ready for bonding.

In case 1, Etch Free rather than a silane coupler was used to aid in bonding to porcelain. Etch Free is a silane-like material that does not require etching of porcelain for bonding to occur; it is designed to be used with Metabond C&B cement. The author felt that etching would increase the surface area and would only increase bond strength. In case 2 the standard silane coupler was used together with the bonding cement.
